## **Restoration Planning at the Sespe Cienega**

### **Literature and Data Review**

#### **PREPARED FOR**

California State Coastal Conservancy

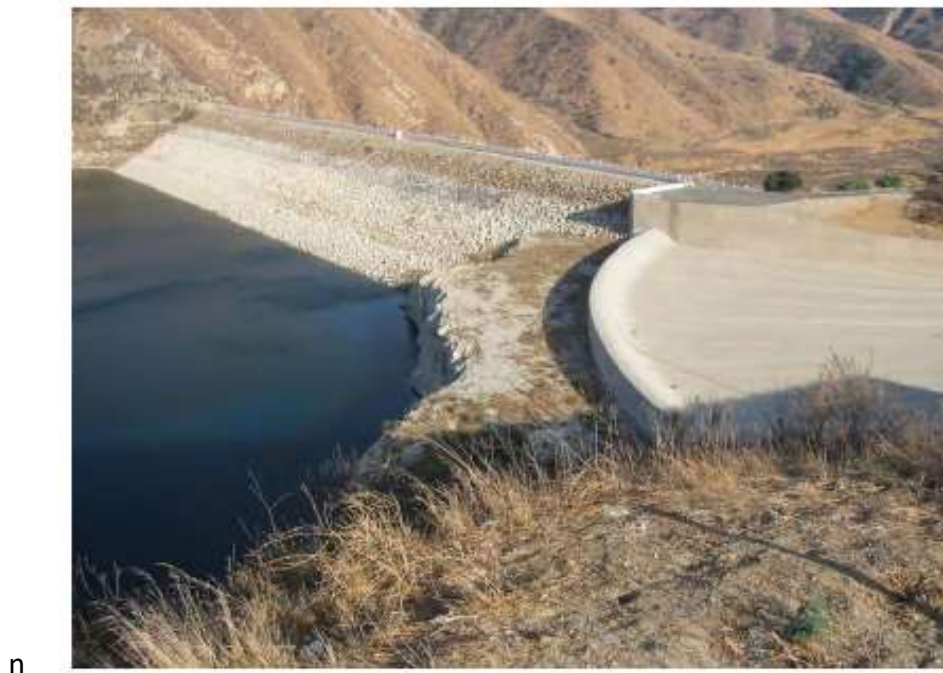
Figure 2.4: View looking downstream from Santa Felicia dam (source: SWS 2007)

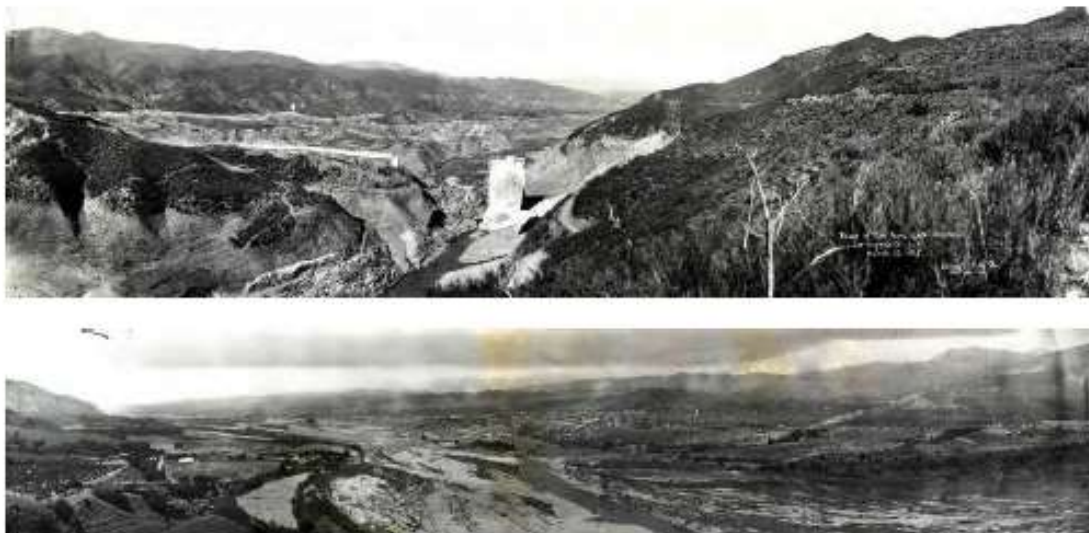
Figure 2.5: Remains of Saint Francis dam, following collapse on 12<sup>th</sup> March 1928 (above), and a downstream view of the mainstem Santa Clara River near Santa Paula the next day (photos courtesy of the Ventura County Watershed Protection District. Source: SWS 2007)

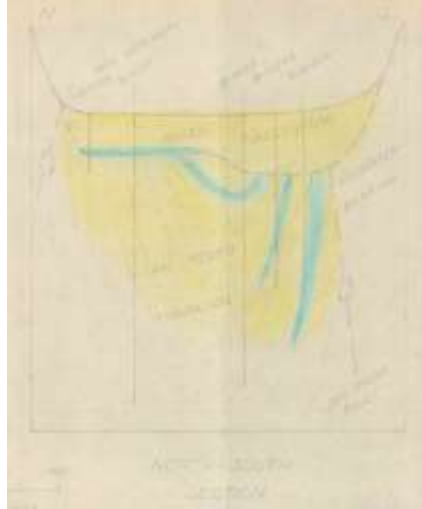
Figure 2.8: North-South cross-sectional stratigraphy in the vicinity of the fish hatchery (Source: Mann 1958).

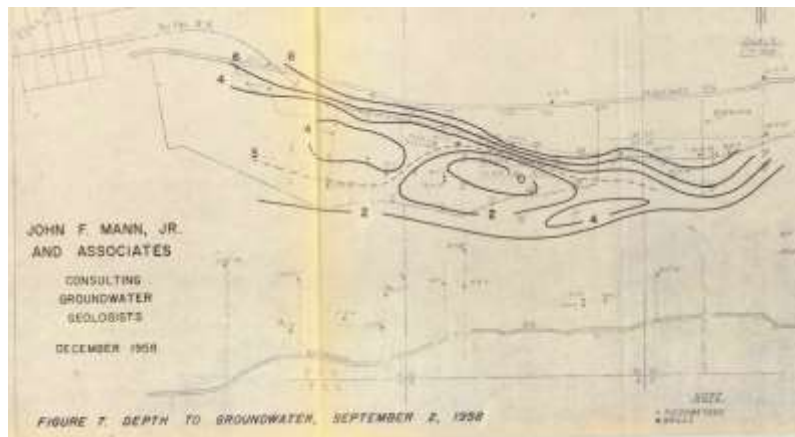
Figure 2.9: Isohyets of depth to groundwater (in feet) at the Sespe Cienega site, September 1958 (Source: Mann 1958)

Piezometer data from Mann's study confirmed the high elevation of the groundwater table at the Cienega (Figure 2.9), that during alternating wet and dry periods from 1927-1959 the western end of the Piru basin was subject to far smaller fluctuations in groundwater level than further east (*i.e.*, upstream), and established the linear east-west orientation of groundwater flow. Such trends are still reflected in recent studies (*e.g.*, United Water 2016, Figures 2.3-2.7). Groundwater flows are now sustained by Fall 'conservation releases' from Lake Piru designed primarily for the benefit of agriculture in areas downstream of the Cienega site. Dye tests indicate that flow releases from Lake Piru take approximately 18 hours to reach the abstraction point at the Freeman Diversion (Paybins *et al.* 1998, Nichikawa *et al.* 1999). The releases make appreciable differences to groundwater elevations in the western end of the Piru sub-basin, seasonally sustaining the shallow depths to groundwater at the Cienega site even in the absence of precipitation. Illustrating this point, recent severe drought in the area prevented Lake Piru releases being made from 2012 to 2015 and resulted in groundwater elevations dropping by approximately 1.2 m per year at the downstream end of the Piru basin (United Water 2016).

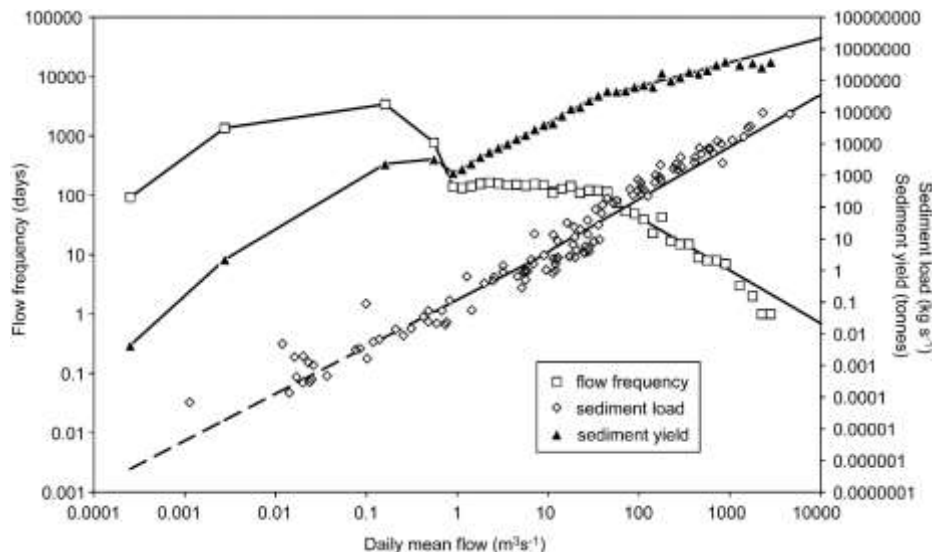
Figure 2.11: Dominant discharge characteristics, lower Santa Clara River (Source: Downs *et al.* 2013)

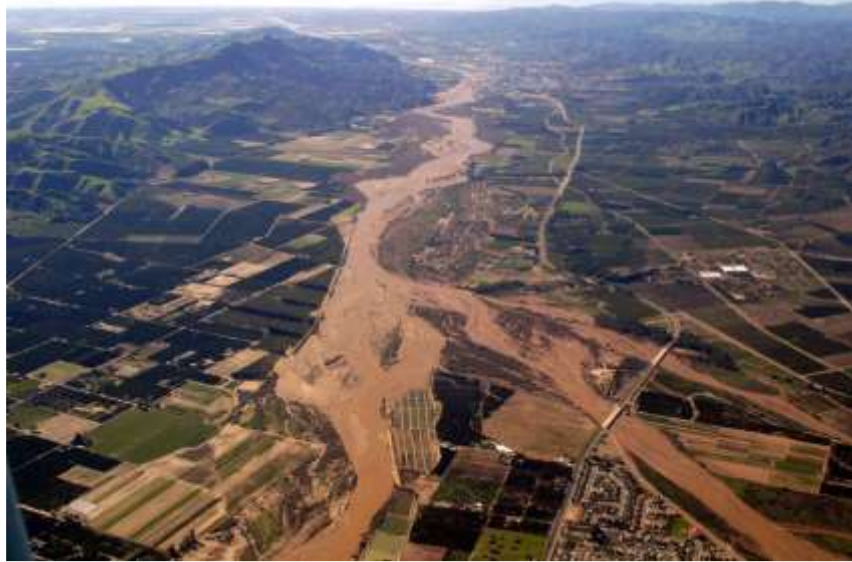
Figure 2.12: Meandering pattern dynamics of the Santa Clara River just downstream of reach 8 as flows recede following the 2005 flood. Receding flows are beginning to expose alluvial bars that will define multiple flow threads during low flows (Source: CCC 2005).

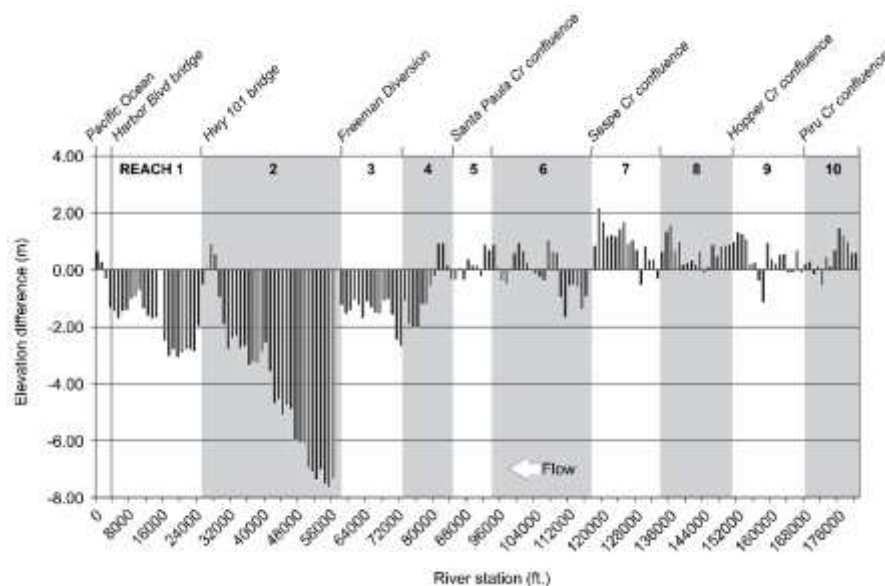
Figure 2.15: Bed level variations in the Santa Clara River 1949-2005 (Downs *et al.* 2013).

In addition to variable widths, repeat thalweg elevation surveys indicate the extent of changing river bed elevation adjacent to the Cienega. Surveys in reach 8 taken between 1929 to 1967-71 and then again in 1993 were compared to LiDAR imagery from 2005 (SWS 2007). During this period, the reach displayed mild net aggradation overall (0–1.5 m, Figure 2.15) but had changed behaviors from overall mild incision from 1929-49 (after St Francis Dam failure but prior to Santa Felicia Dam), upstream incision grading into downstream aggradation 1949-1969, and overall mild aggradation thereafter. Given the general increase in overall net aggradation from reach 10 downstream to reach 7 at the confluence with Sespe Creek, one explanation is plausibly that decreased flood flows into the reach caused by flow regulation has caused a progressively greater backwater effect from Sespe Creek that has promoted increased sediment deposition.

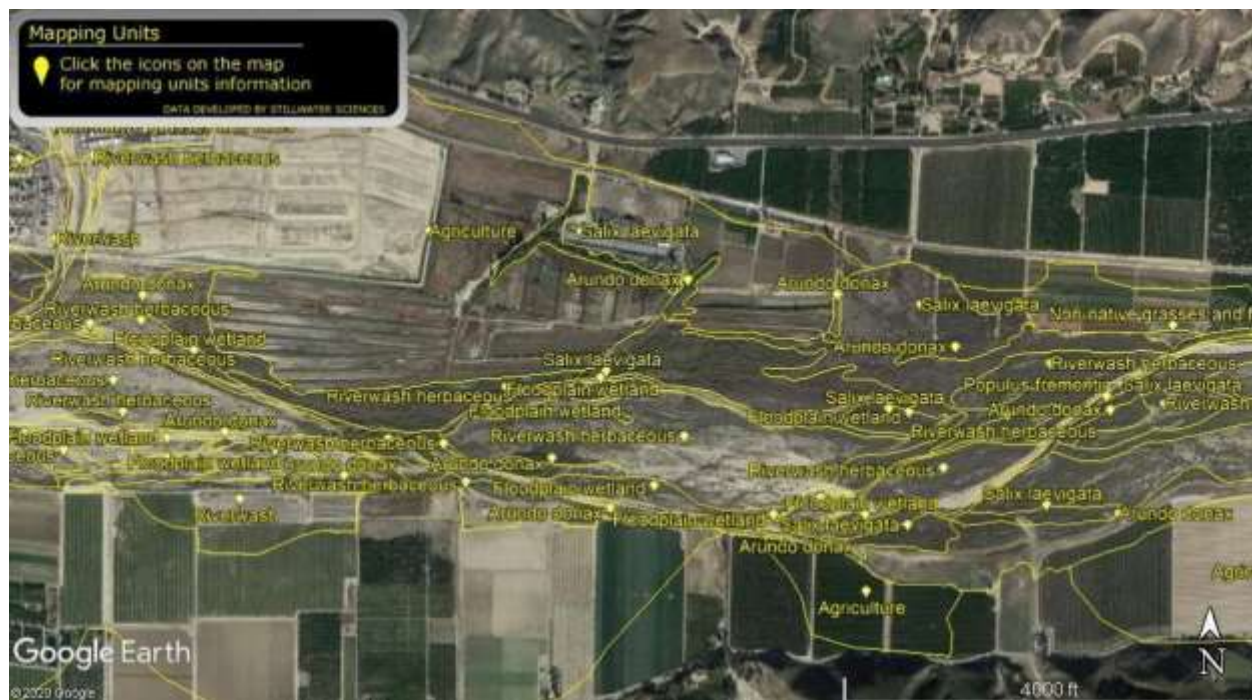
Figure 3.2. Vegetation community overview of the Sespe Cienaga.

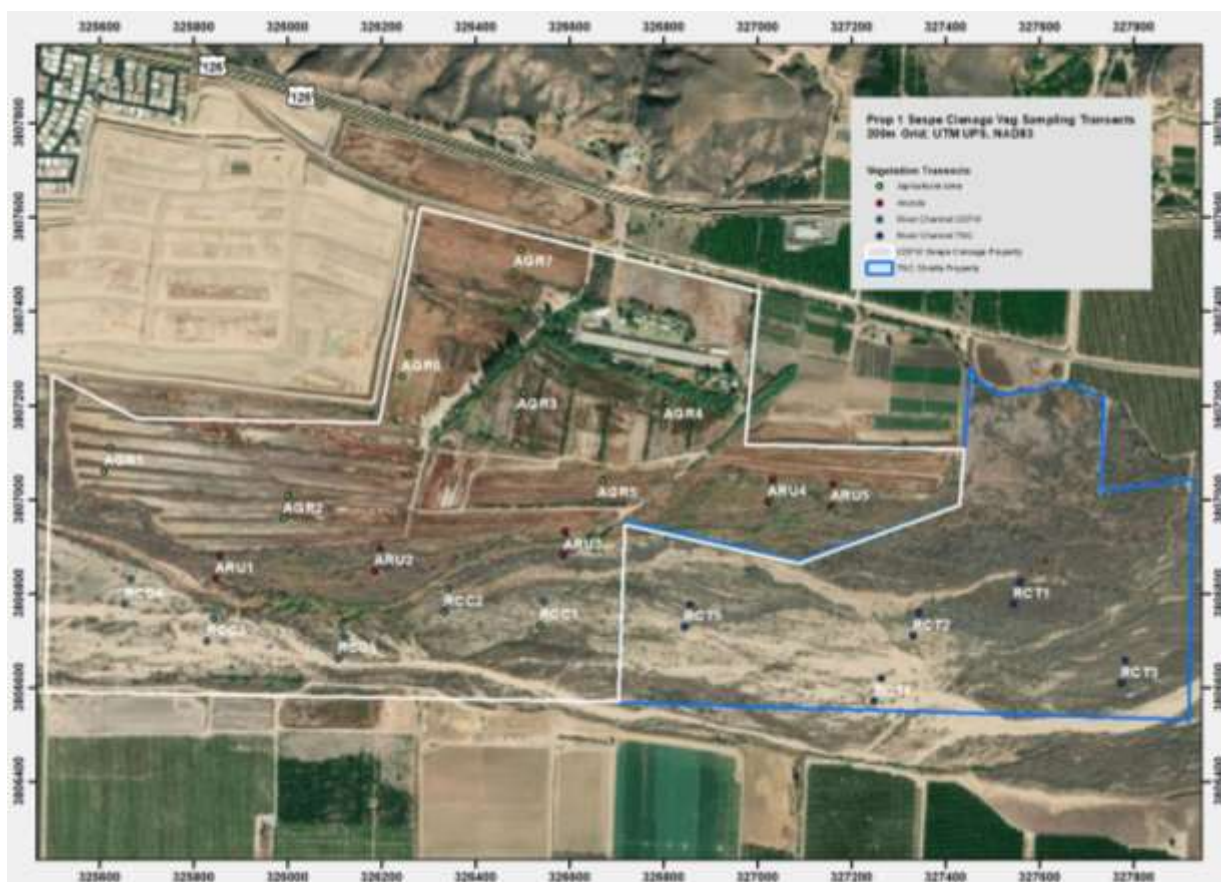
Figure 3.3. Overview of the 22 permanent vegetation transects installed for the Sespe Cienega project across the three vegetation communities: historic agriculture (green), monotypic arundo (red), and river channel (light blue). The river channel system was also sampled on neighboring Nature Conservancy property (dark blue).

In June 2019, SCRC and UCSB completed systematic vegetation surveys at the Cienega to assess baseline conditions and track ecological changes from restoration activities. The project area was stratified into three sampling areas based on management histories resulting in distinct vegetation communities: historic agricultural (160 acres), monotypic arundo (50 acres), and river channel areas on the CDFW (80 acres) and TNC (100 acres) properties. In total, 22 permanent 50-meter transects were installed throughout the project area, including five transects at the neighboring TNC property (Figure 3.3). Cover and frequency of annual and perennial taxa were documented using a combination of quadrat, line-intercept, and point-intercept sampling methods. Permanent photo points were established to visually document changes in vegetation cover over time. These data provide a comprehensive assessment of cover, species richness, and abundance within each habitat type.

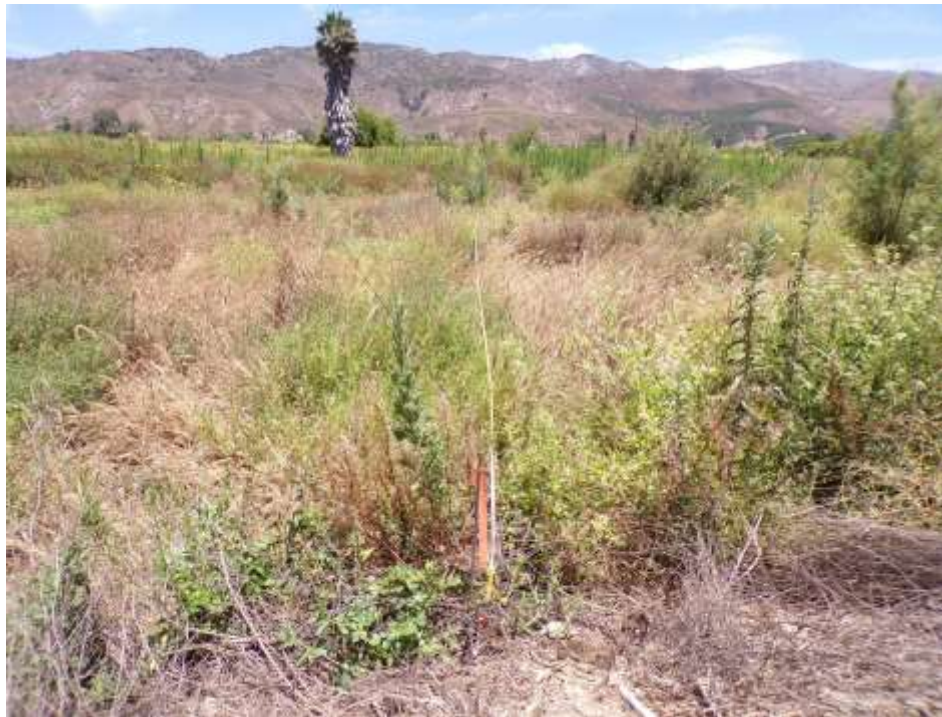
Figure 3.4. A characteristic example of the historic agricultural vegetation community, dominated by herbaceous, largely introduced taxa (transect AGR5).

Remnants of willow-cottonwood forests occur along the riverbank, side channels, and terrace where adequate soil moisture is present and flooding disturbance is infrequent. This vegetation community consists of willows (*Salix laevigata*, *S. exigua*, *S. lucida* ssp., *S. lasiandra*, and *S. lasiolepis*) and cottonwoods (*Populus fremontii*, *P. trichocarpa*), mule fat (*Baccharis salicifolia*), sycamore (*Platanus racemosa*), blackberry (*Rubus ursinus*), mugwort (*Artemisia douglasiana*), and other understory species. However, much of the potential riparian forest habitat is heavily invaded by *Arundo*, and to a lesser degree, castor bean (*Ricinus communis*) and tamarisk (*Tamarix ramosissima*, *T. parviflora*). Vegetation data from 2019 surveys indicated that very little of this community is present on the project site. Although over half of the transects sampled in the historic agricultural and monotypic arundo sites had dominantly moist or saturated soils in late summer, one characteristic favorable to recruitment and establishment of both willows and cottonwoods, no related taxa were documented during our sampling. Instead, these moist upper terraces were dominated by introduced taxa (canopy cover: historic agriculture 54%, monotypic arundo 64%), and of primarily herbaceous and grass functional groups (canopy cover: historic agriculture 94%, monotypic arundo 66%) (Figures 3.4 and 3.5).

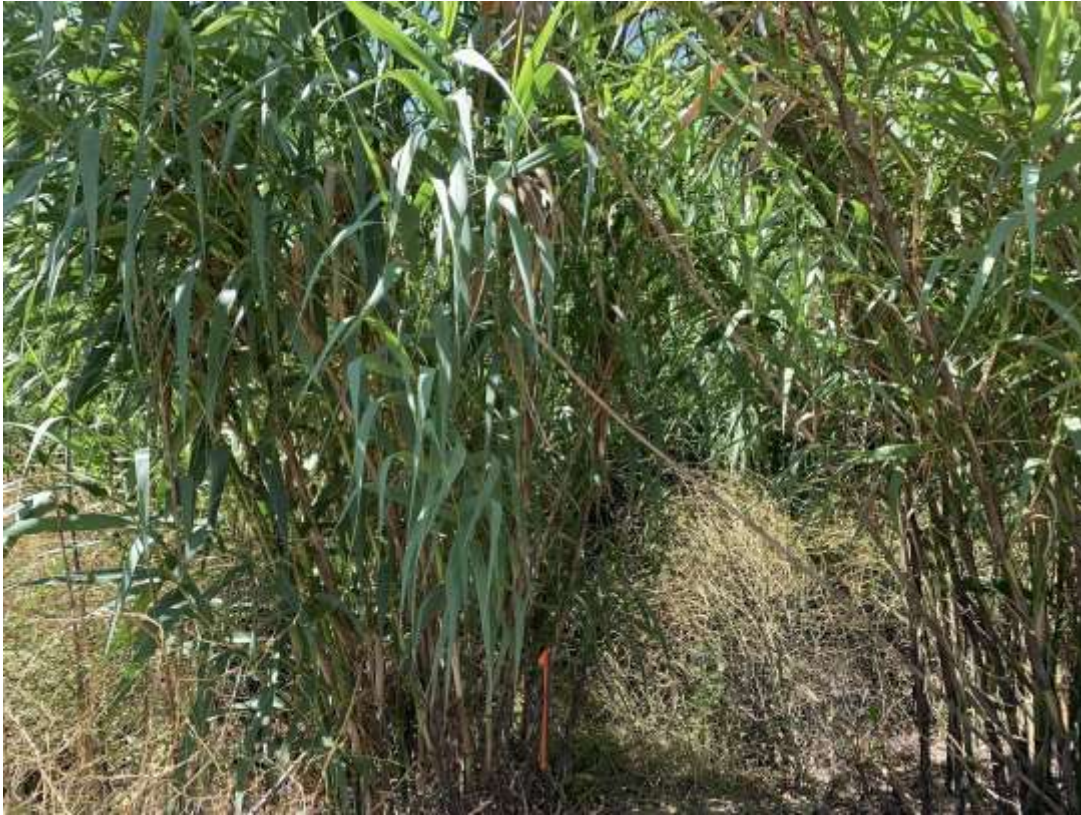
Figure 3.5. Looking into a previously untreated area of the monotypic arundo community, dominated by arundo and introduced herbaceous species (transect ARU4).

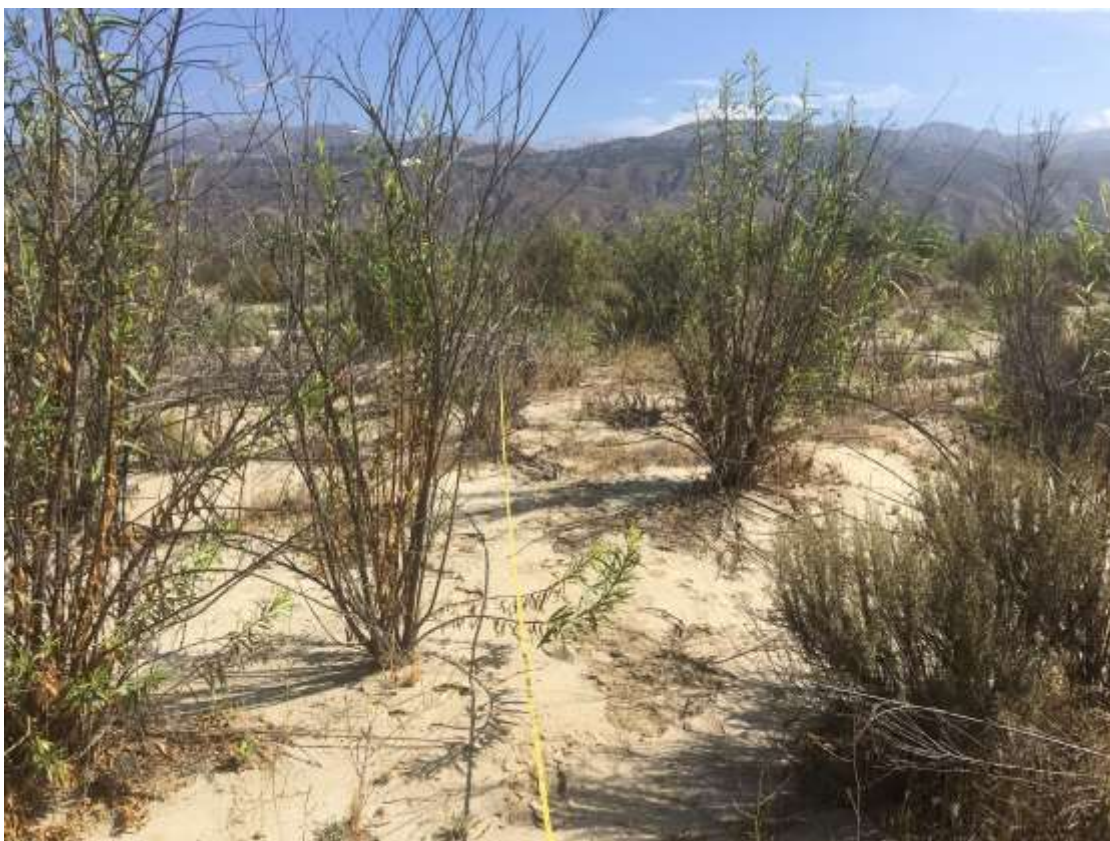
Figure 3.6. A characteristic section of the river channel vegetation community, dominated by native shrubs and open space (transect RCC1).
